Washington Department of Ecology Everett Smelter Site Summer 1999 Cleanup

Details of Cleanup Activities

Property Owner: Tim Smith

Address:
211 Medora Way
Everett, WA 98201

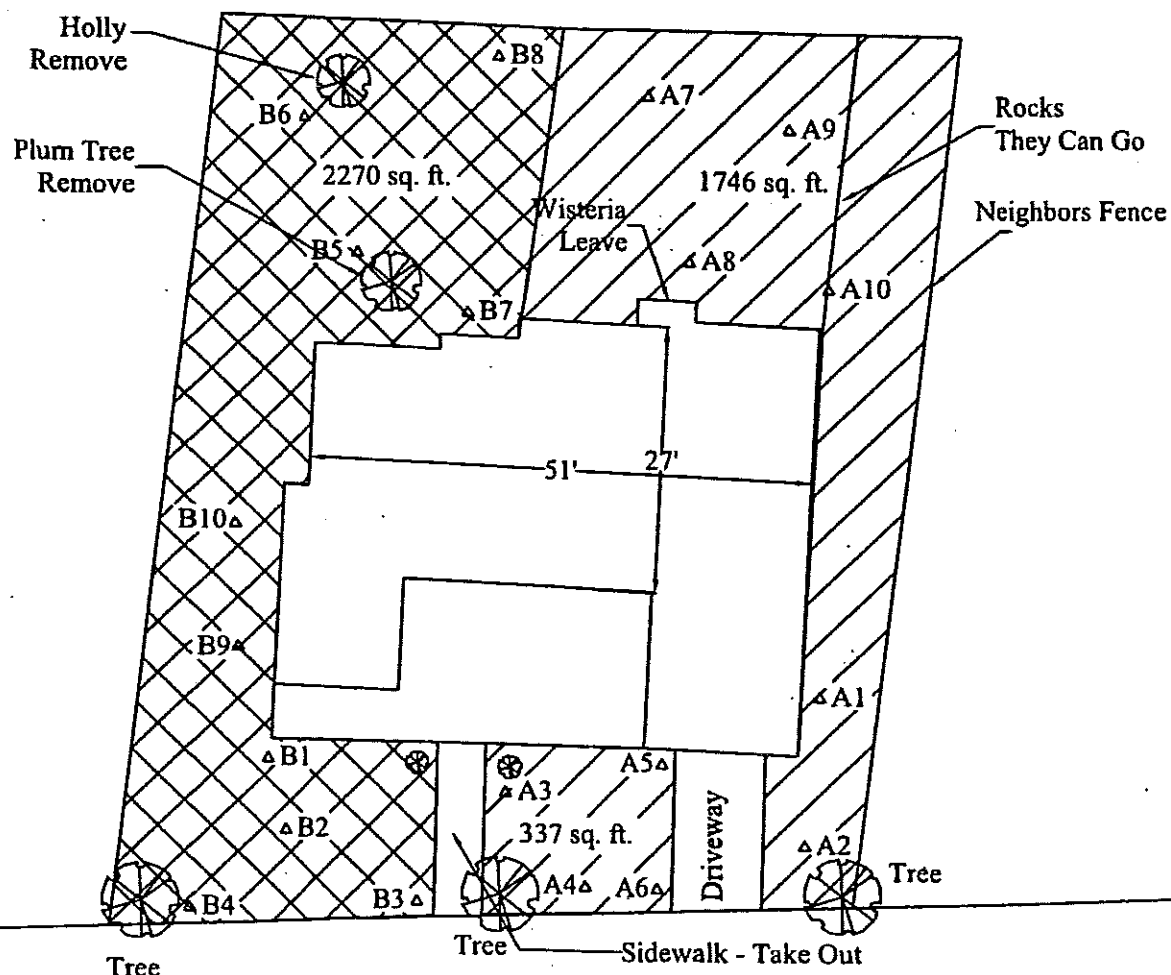
This property was divided by Ecology into two Decision Units, A and B, as shown on the attached map, for purposes of pre-cleanup sampling and decision-making regarding the depth to which excavation was required. The following is a summary of the work done in the remediation of the property within each of the decision units.
